Model: MP3 all versions, Fuoco 500

Subject: Greasing the bearings of the side sleeves.

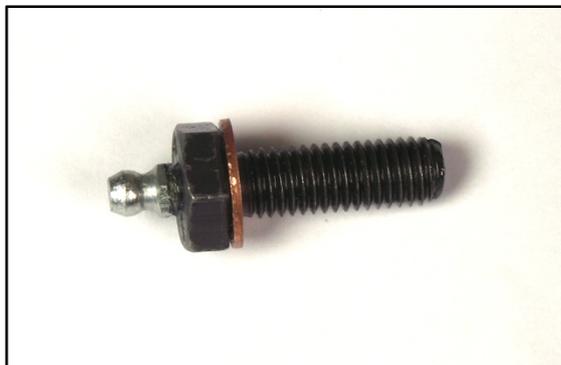
P/N 020943Y

SCREW WITH GREASER

To integrate/restore the proper lubrication of the bearings, the following specific tool has been defined:
